SANTA MONICA BAY NATIONAL ESTUARY PROGRAM

New Zealand Mudsnail Surveys

Santa Monica Mountains

December 2015

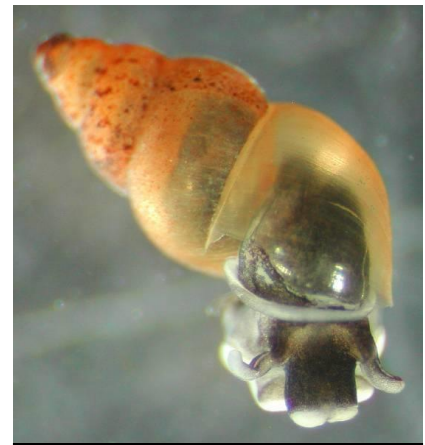
Figure 1. New Zealand Mudsnail

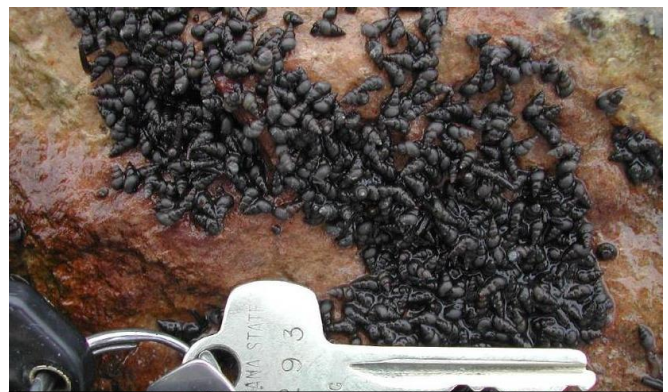
Figure 2. NZMS at high density clinging to a single rock.
